Water Resource Pollution and Impacts on the local livelihood: A case study of Beas River in Kullu District, India

Mishra, P Ranjan., and Nadda, R.K. (2014). Water Resource Pollution and Impacts on the local livelihood: A case study of Beas River in Kullu District, India, *Future of Food: Future of Food: Journal on Food, Agriculture and Society*.2 (1): 61-75
ISSN-Internet: 2197-411X / OCLC-Nr.: 862804632

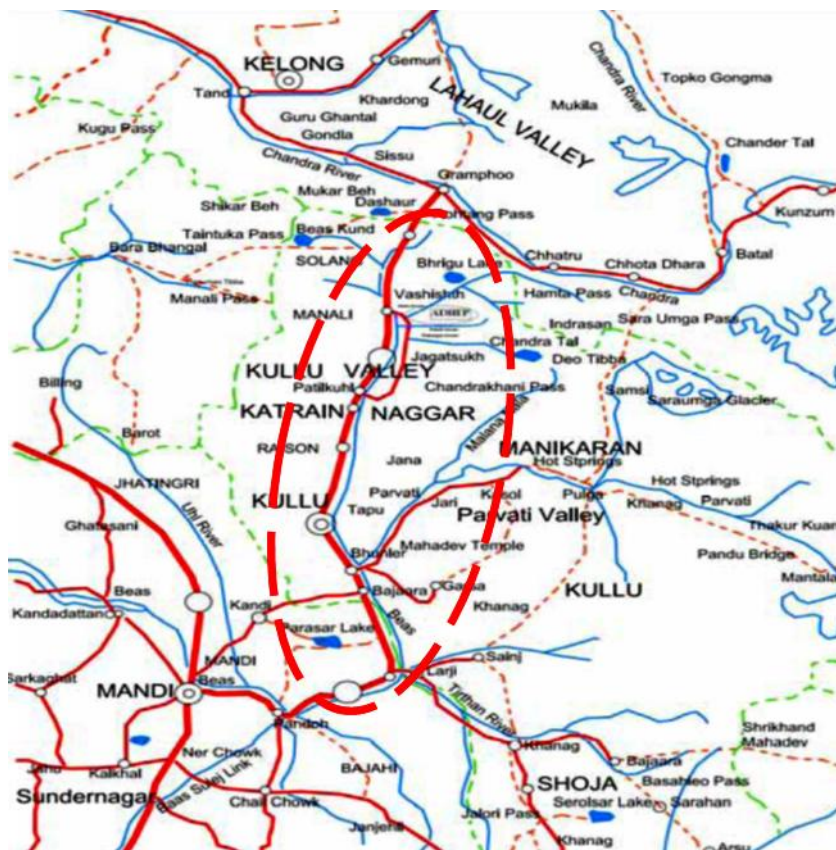
Figure 2 Map showing the exact location of the sampling points marked as tiny white circles over the red line depicting river in the valley (Source: Non-Technical Summary, Environmental and Social Impact Assessment: 192 MW Allain Duhangan Hydroelectric Power Project, Tehsil Manali, District Kullu, Himachal Pradesh, February 2009, Page-2).

The study area comprises of Beas River from Manali to Larji along NH21 between upstream Manali town and downstream of Larji dam at 15 locations. The actual points of sampling for the study have been shown above the thick broken red line that shows the Beas River in the

middle of the map (Figure 2). The study points were carefully chosen so as to get representative samples in order to interpret the impact due to sewage and solid waste dump into the river.

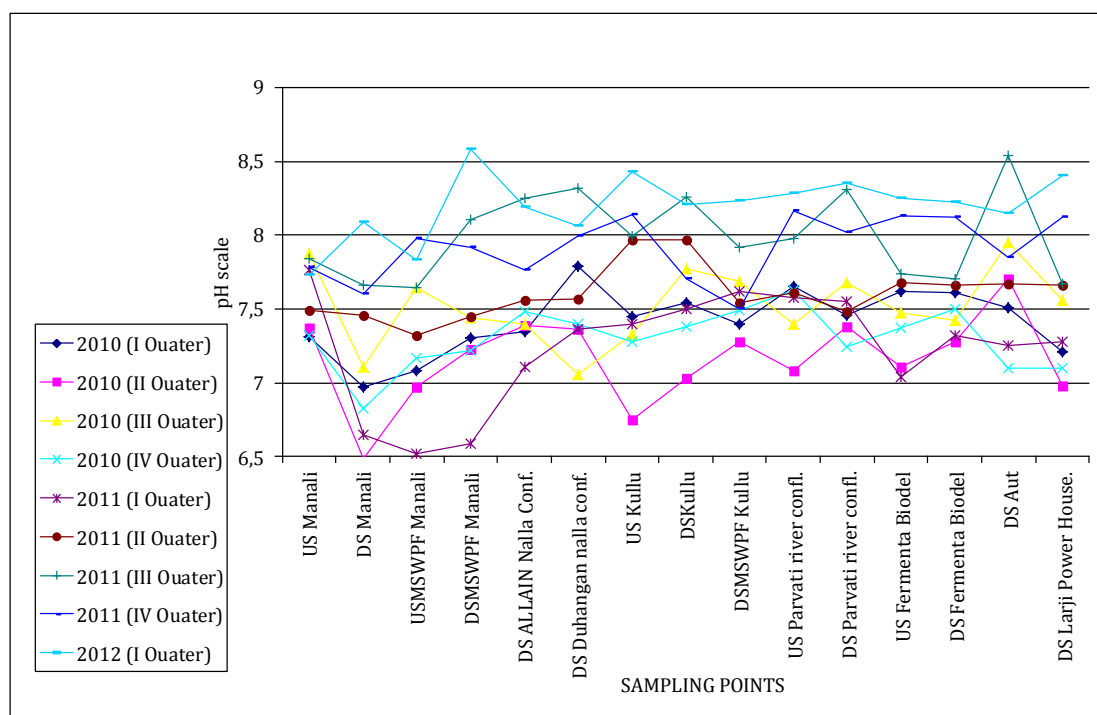
Figure 3 pH Variation during study period

The analysis of the pH graph shows that pH values remain in between 6.5 to 8.5 in all the quarters of the study period which is in an acceptable zone according to surface water quality standards. It has also come into the picture that the pH value has decreased in DS Manali as compared to US Manali on consistent basis in almost every studied quarter due to the pollution load of Manali city. Downstream of Kullu has also shown similar results, which is indicative of

the fact that the river stretch between these municipalities receives organic pollutants in the form of leachates from solid waste dumps and the untreated sewage.

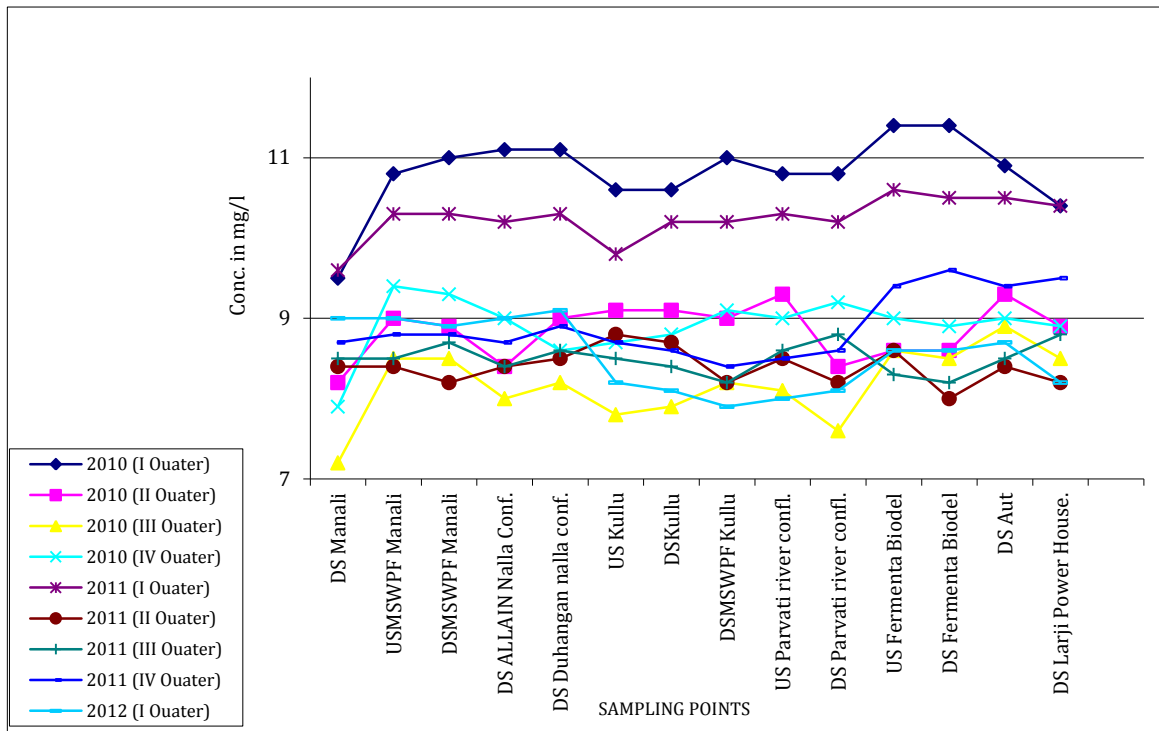
Figure 4 DO Variation during study period

After analysing the DO graph, the results show that the DO level ranges from 7 to 11 mg/l throughout the river stretch under study. The DO level in Beas River is quite high due to

its turbulent nature. The graph shows that there is drastic depletion in the DO level at DS Manali as compared to US Manali which indicates the contribution in pollution due to Manali town. It is also noticed that the DO level increases towards reaching DS Larji power house in most of the quarters as the river gets stabilised after reaching Kullu. This justifies the river self-purification process and the Biochemical Oxygen Demand (BOD) stabilization.

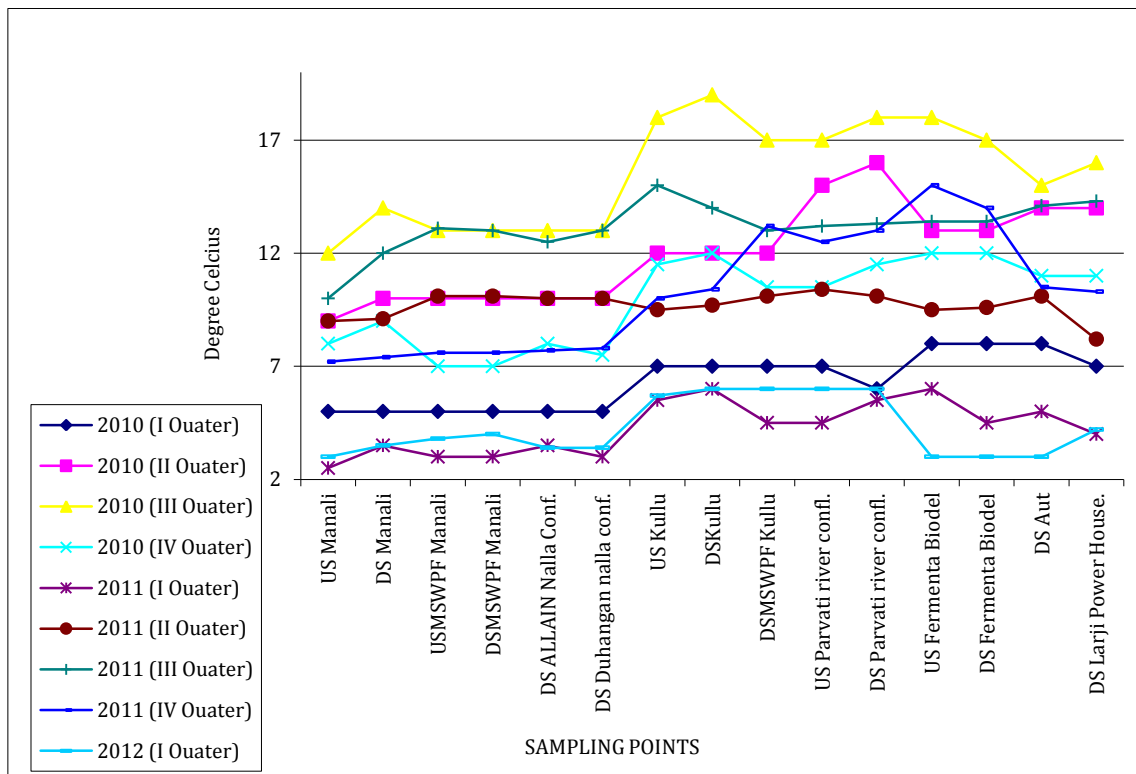
Figure 6 Temperature Variation during study period

The temperature graph shows that the temperature ranges from 2.5 to 19 degree Celsius which shows only seasonal variations. However, temperature of river water has been found to be comparatively high at all downstream points of sampling.

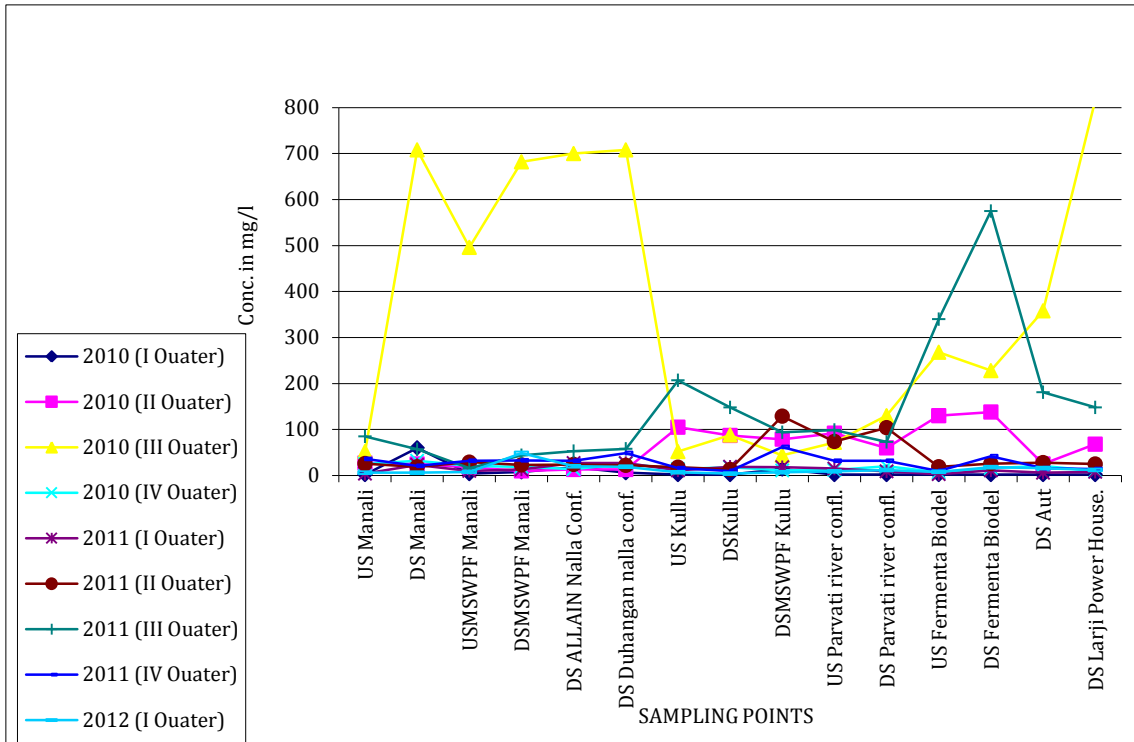
Figure 7 TSS Variation during study period (More clear illustration in appendix)

The TSS graph shows that the TSS values are high in the third quarter of

both the years which is only due to the pre-monsoon period. In the rest of the quarters the TSS values are quite stable. It has also been observed that in the year 2010 the TSS value of DS Manali is higher as compared to US Manali which is only due to the pollution load of Manali city as indicated from above parameters. TSS values are higher on account of increased construction along the river banks in one form or the other. The hydropower companies also flush their silt from time to time.

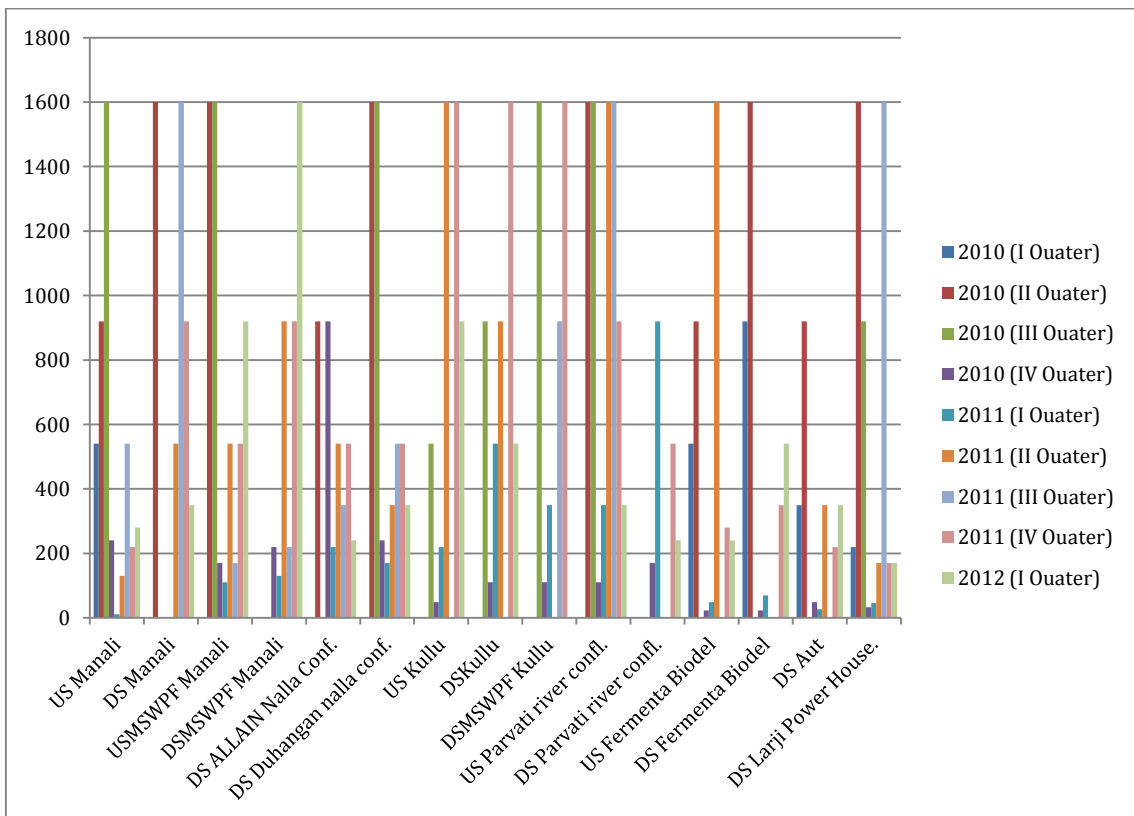
Figure 8 Total Coliforms (MPN/100ml)

During the study period, bacteriological sampling was also carried out at every point as pollution in DS cannot be ruled out due to various anthropogenic activities, and it is supported from the study that Coliform level (TC & FC) were found at increased levels at all DS points of the study area (Figure 8). The Total Coliform level (Most Probable

Number/100 ml) is more than 500 in contrast to the standard of less than 500 set by central Pollution Control Board in India for outdoor bathing or recreational activities (Figure 9). The TC level should not exceed a number of 50 for drinking water as per the same standard, but on contrary the Total Coliform level at the sampling points have been found to be more than the standard required for drinking water.
