Experimental Investigation on a Full-Scale Replica of the Closing Mechanism in Cheops' Antechamber

Research Report

Part 1: Motivation, reconstruction and major insights

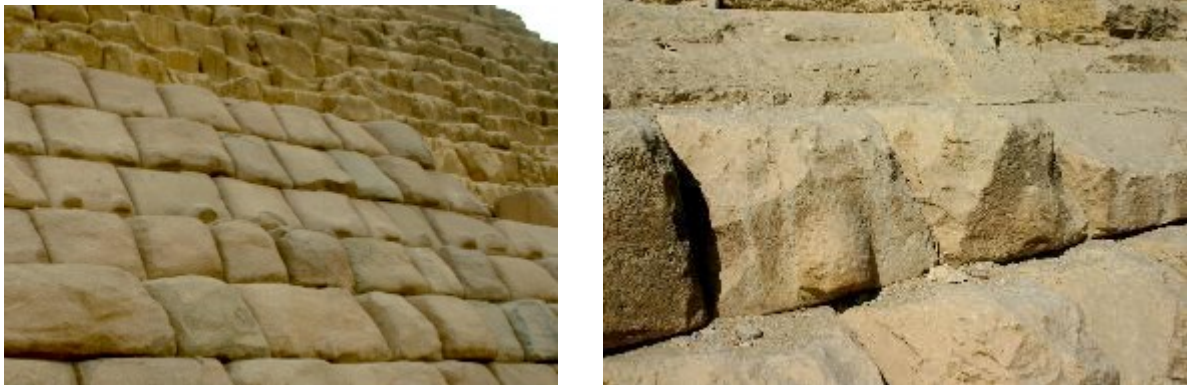
Fig. 3. Bosses on the facade blocks of the Mykerinos Pyramid (left) and one of Cheops' side pyramids (right) bear witness to the fact that, they were lifted into position. (photos by U.E. Dorka)

Note that the flat face of the bosses is always down, not sideways or up. This is the only face where a rope can exert a force on these bosses, which therefore will always point upwards. Thus, these bosses can only be used for lifting and lowering, not for pulling sideways.

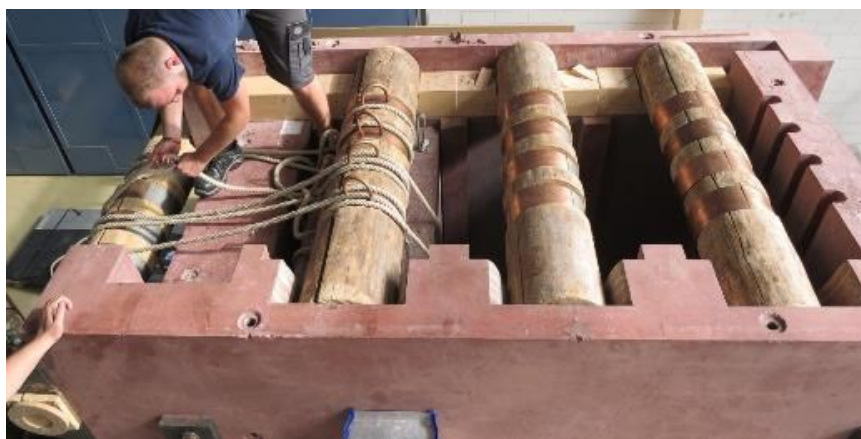
Fig. 4. Top view of the antechamber replica with the south wall to the right. The northern portcullis (N-block) is in its topmost position sitting on a timber beam (fig. 5) while a test is prepared. Note the rounded-out timber wedges on the flat recess of the east wall that provided proper bearings for the logs. (photo by A. Klarendic)

Geometrically feasible diameters for the three logs can be derived from the hollows in the west wall. They must be around 15 - 20 cm in order to avoid single point contacts, which would split the timber under such loads. They also provide enough bearing in the hollows against sideway motion. The east wall does not have hollows, but a flat recess approximately at the height of the low points of the hollows and a depth similar to them. To provide the necessary bearing stability for the logs here, we chose rounded out timber wedges with radii similar to the ends of the logs (fig. 4).

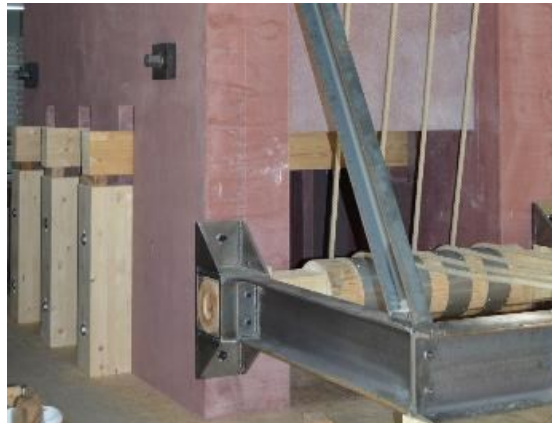
Fig. 5. North entrance of the replica with timber beams placed underneath the portcullises for safe handling during test preparations. The beams were removed just prior to testing. Note the end plates of two steel rods (out of four) that connect the prefabricated concrete elements. The steel frame and log in front are part of the force measurement system. (photo by C. Nguyen)

East, west and south wall reconstructions ended just above the hollows of the west wall in order to provide safe seating for the timbers and easy access during test preparations (fig. 4). East and west wall have rectangular openings at the height of the entrance to the chamber so that wooden beams could be placed safely from the sides underneath the portcullises when they had to be handled during test preparations (fig. 5).

All concrete parts were prefabricated, delivered to the lab and assembled on site. They were connected with four 40 mm steel rods (the ends of two are seen in fig. 5) that ran through the south wall and northern stone leaf. This reconstruction can be easily disassembled, moved and reassembled in another location.

After a completed test the portcullises were lifted by a crane, placed on wooden beams (fig. 5) and the ropes were re-configured for the next test. Then, the crane lifted the portcullises one by one, the wooden beams were removed, and the portcullises hung into the ropes, which all the while were held by the handlers. The forces were measured during the whole process until the handlers had lowered the portcullises.

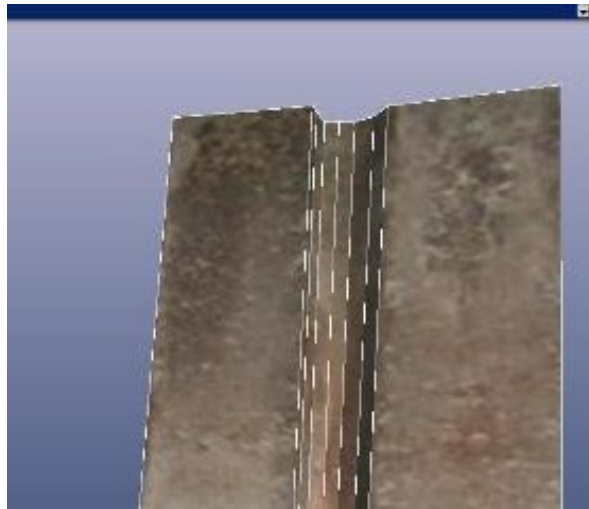
Fig. 6. Using an appropriate set of pictures, photogrammetry can create a three-dimensional image in the computer, here of a vertical groove in the south wall. In this case, local measurements were taken with mm accuracy from this 3D image to confirm the shape of the grooves. This provided important information on the likely diameter of the ropes (about 20 mm).

Where recorded dimensions were insufficient or questionable, photogrammetric measurements were taken (fig. 6). In this case, they can be obtained with mm accuracy from appropriate pictures that have a reasonable resolution.

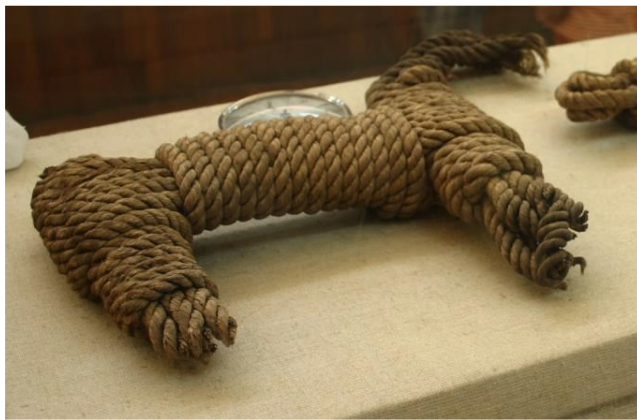
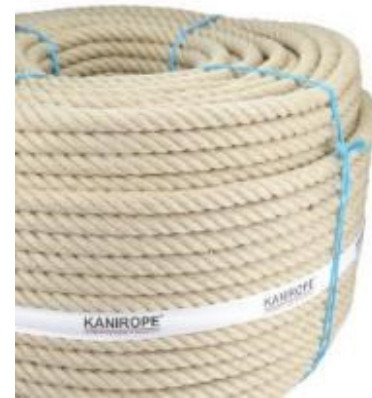
Fig. 7. Twisted halfa grass rope in a sophisticated configuration found with Cheops’ sun bark (left, photo by U.E. Dorka) and diameter 20 mm 4-strand twisted hemp rope used in the tests (right, from KANIROPE product description)

Concerning the ropes, we opted for twisted hemp ropes, which have a similar surface geometry and texture as the ropes found with Cheops’ sun bark (fig. 7).

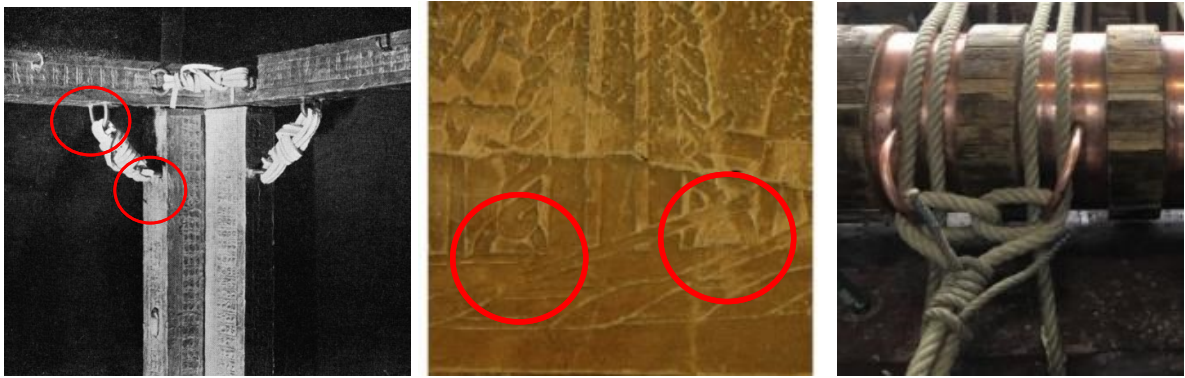
Fig. 10. Copper hoops provided releasable connections and enabled prestressing in the bed canopy of Hetepheres (4th dynasty, left, picture from⁶) and on a 5th dynasty transport ship to tie and release the mast (approach to Unas’ pyramid, centre, photo by U.E. Dorka). We used them in a similar fashion on the northern log for simultaneously releasing and controlling two ropes (right, photo by C. Nguyen).

Considering that in those days copper was the material of choice for metallic connections in timber structures (see the bed canopy of Hetepheres, fig. 10, left), we provided copper plates where the ropes moved over timber (fig. 9, right).

After test 26, we knew that operating this mechanism smoothly requires some experience, so we had a few runs for the two handlers to familiarize themselves with the operation of the controller (fig. 10, right). This required again the removal of the measurement system. Minor changes were done to the configuration during this training (rope brakes only on ropes 2 and 3, ropes fixed on M-log), so we measured the final configuration in test 40. Although one rope ruptured due to excessive wear, forces did not vary much when compared to tests 24-26. With no new insights gained from these measurements, we decided not to repeat the test.

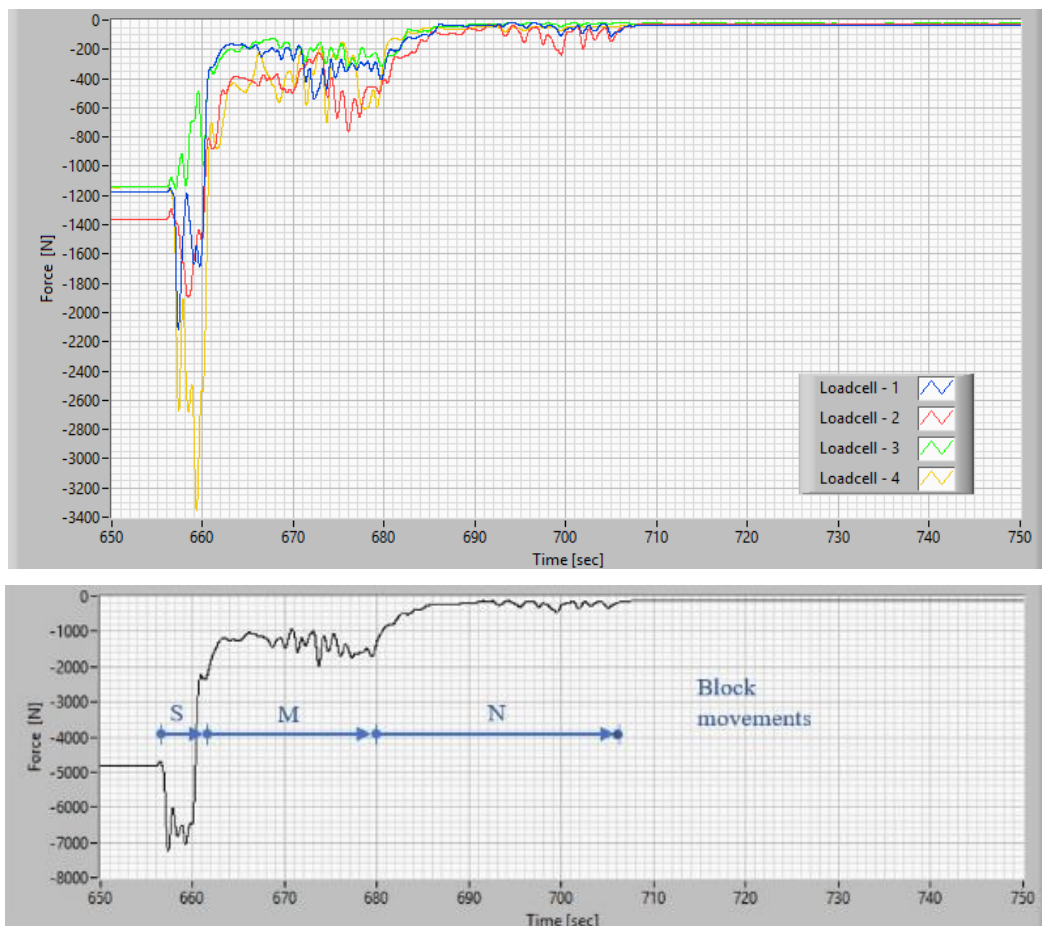
Fig. 11. Test 25: Forces (factor 2) during release. Note the large difference between each rope caused by individual handling (top diagram). The sum of all forces (bottom diagram) shows small jitters when a portcullis is moving and a rapid but gradual drop when it reaches the floor. Three phases are visible: S-block moves at 656 s with 3200 N and is down at 661 s when M-block moves with 750 N. M-block is down at 679 s when the remaining N-block moves with a mere 150 N.

Rope forces varied widely during operation depending on the way each rope operator handled his rope (Fig. 11). A rope can rupture because of this (as it did twice).

The measurements of test 25 are representative for the configuration that allowed a smooth operation of 3 portcullises showing all phases clearly (fig. 11). Total force drops 76% after S-Block is down and 80% after M-block is down. This is in line with the “corner friction” ($\mu = 0.73$) measured in single rope tests with lubrication (see Part 3.2). To see the results of all tests listed in tabs 2 and 3, the reader is referred to Part 2 of this document.

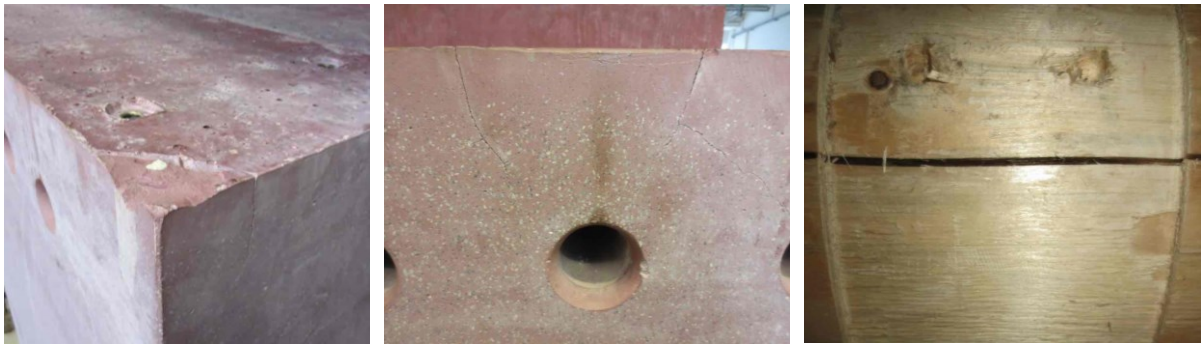
Fig. 13. Damage to the upper corner of N-block (left), cracks above the holes (middle) and damage to a tenon hole in one of the logs after the end of the campaign. (photos by S. Schuster)

After repeated testing, the tilt caused damage to the portcullises' edges and corners, especially to the N-block, which had been used more than 40 times (fig. 13 left). In addition, cracks started to grow from the holes and eventually formed wedges that fully separated the region above (fig. 13 middle). In plain granite, these regions would have failed most likely after about 10 tests. Such damage only appeared after

There was also some damage to the tenon holes in the timber (fig. 13 right) attesting to the large shear forces that the copper plates had to transfer to the logs. Without the protection of these plates, the logs would have been destroyed almost immediately (see Part 3.1).
